Low Velocity Car-to-Bus Test Impacts (slightly abridged)

*Written by Robert A. DuBois, Bruce F. McNally, Joseph S. DiGregorio, Gary J. Phillips
Published: Accident Reconstruction Journal, Vol. 8, No. 5, Sept/Oct 1996*

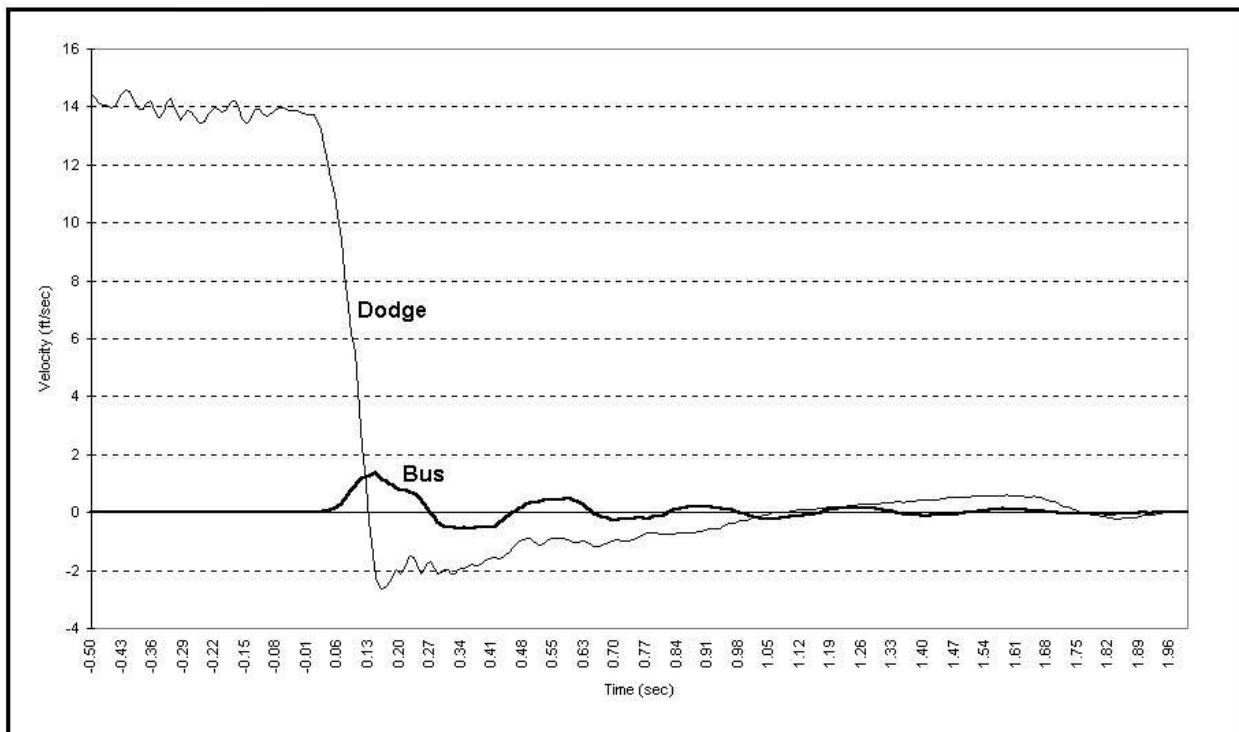
Figure 6 - Velocity Readouts for Flexible Bus and Dodge Spirit, Test 13

Table 1 shows the data from the eighteen crash tests. Figure 6 shows the fifth wheel speed data from test #13. Figure 7 shows the fifth wheel acceleration tracing from test #13.

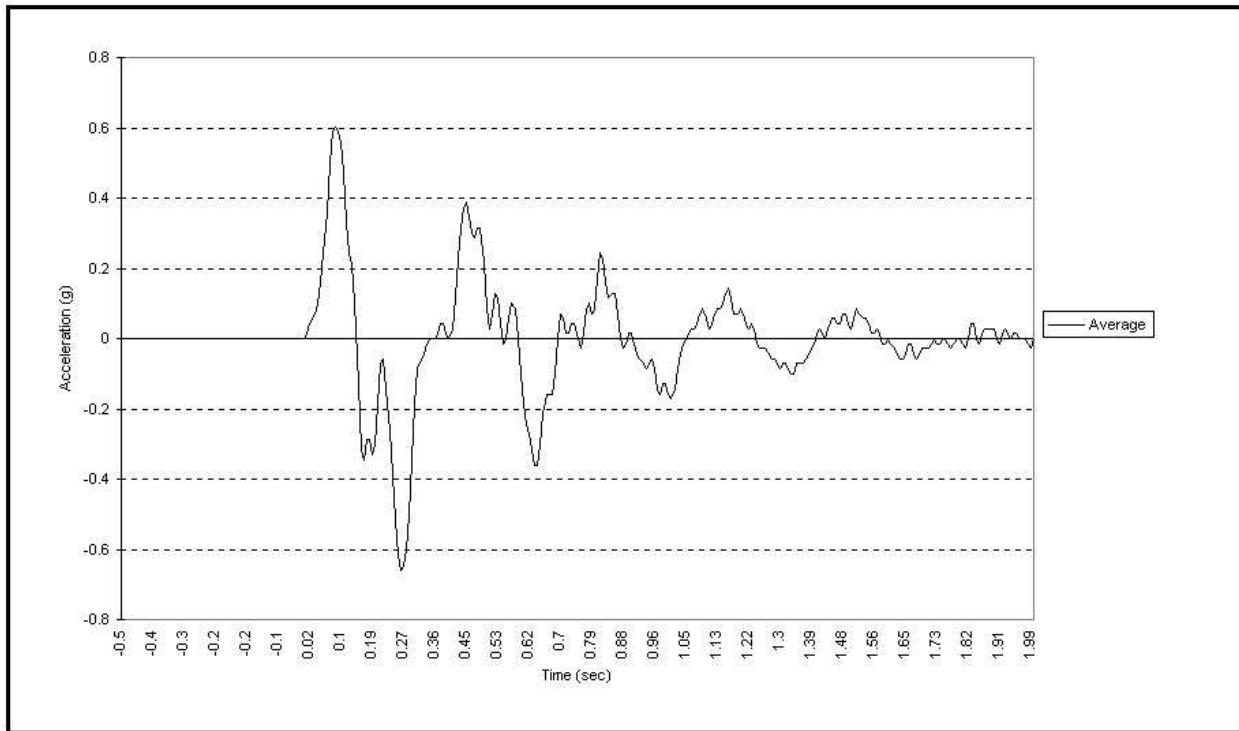
Figure 7 - Acceleration Readout for Flexible Bus, Text 13
